Towards improving evacuation operation on passenger ships through investigations of past passenger ships accidents

Ibrahim Elsayed Shehata

Abstract: The paper reviewed the investigation reports and media reports of passenger ships accidents through the past two decades. In addition to personal interviews with people involved in order to study the root causes of the accident, the reaction of crew and passengers, and the efficiency of the evacuation process.

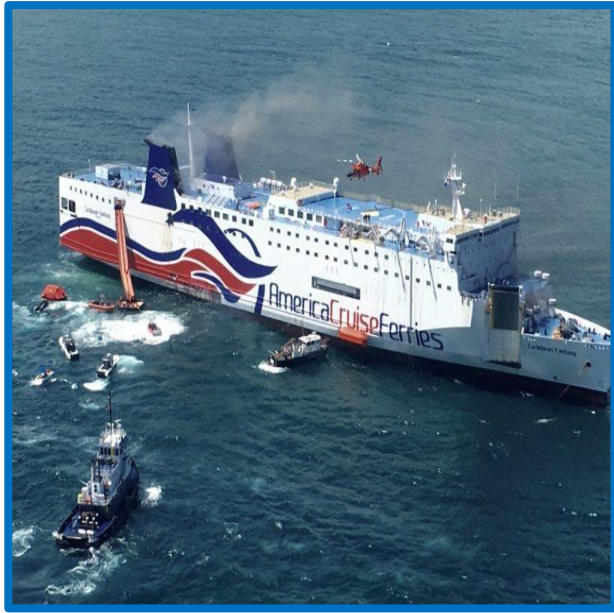
Fig. (1)
CARIBBEAN FANTASY on scene SAR operations

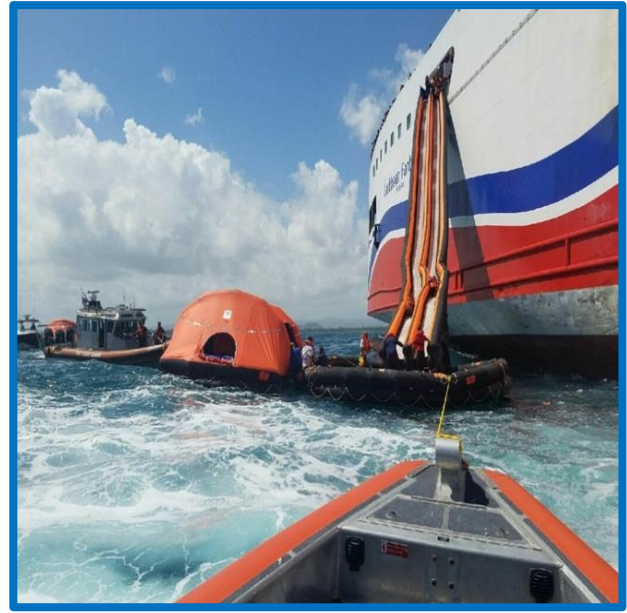
Fig. (2)
Close look to the deficient MES

Life boat no. (1) faced difficulties releasing the hooks and suffered from engine failure. Life boat no. (2) faced difficulties releasing the hooks. Life boat no.3 failed to release the hooks and was hoisted fully loaded against the winch design which made it hang six feet above water line. The MESs were installed on either side of the ship but the port side MES was not deployed because of the flames and smoke coming from the port side. The starboard MES was also not deployed as designed. The slide was kinked, with an extreme angle at the top of the slide and a flat angle at the bottom, due to that kink, several passengers suffered injuries. A Coast Guard vessel solved this problem by fixing a line to the floating platform of the MES to pull the slide out straighter and prevent further injuries.

1- It is recommended that in future ship building designs, the survival crafts and MES should be protected and thermally isolated such in case of fire, people can board and use that equipment without being damaged, this protection shall be capable of protecting the crafts for a duration of time not less than the time required for evacuation as per SOLAS requirements.

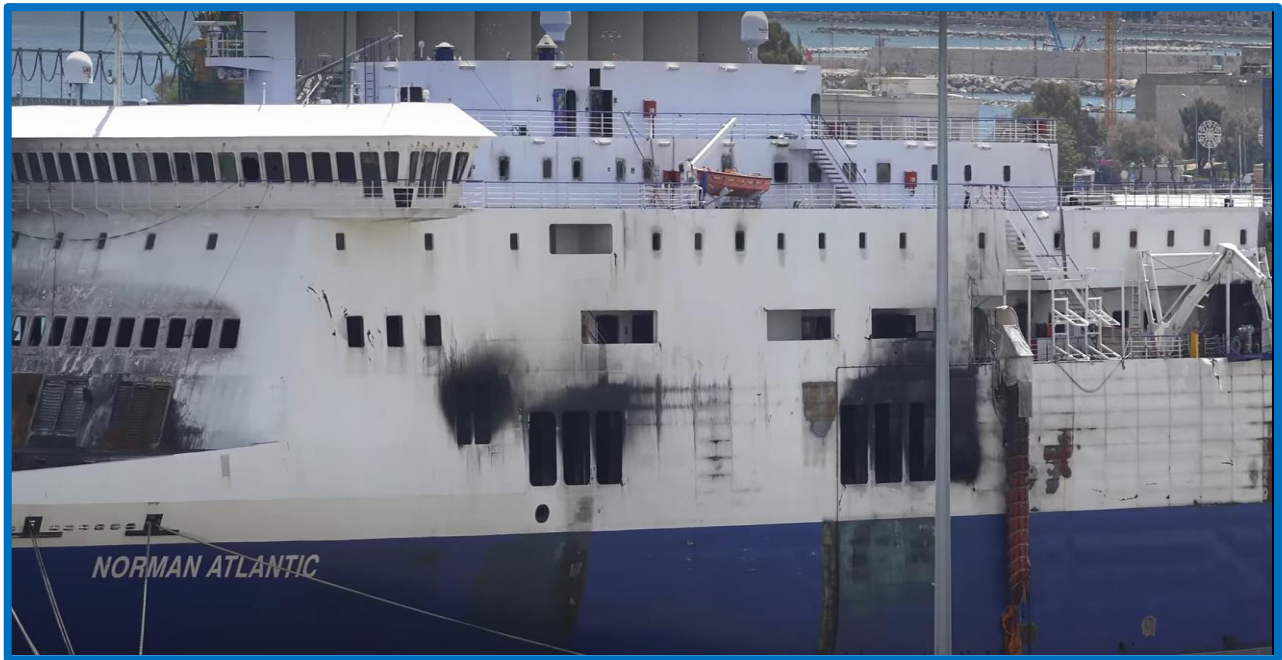
The rescue boat on the starboard side was destroyed by the flames coming out from deck (4), also the mini-chute on the starboard side could not be used, as it was destroyed by flames. The boat on the portside was lowered to the embarkation deck by the crew following the captain's order. Afterwards, without any orders from the Captain, 88 persons got on board the lifeboat that was lowered to the sea. Also the life rafts placed on the portside of the ship were launched in water, without the Captain's authorization and the control of the crew members appointed. It is probable that some passengers used the MES, placed on the portside of the ship, and boarded on the life raft. However, after a while the life raft separated from the vessel.

Fig. (3): Illustrates the damaged starboard side chute which was never used in evacuation. Source: (MIT, 2018)

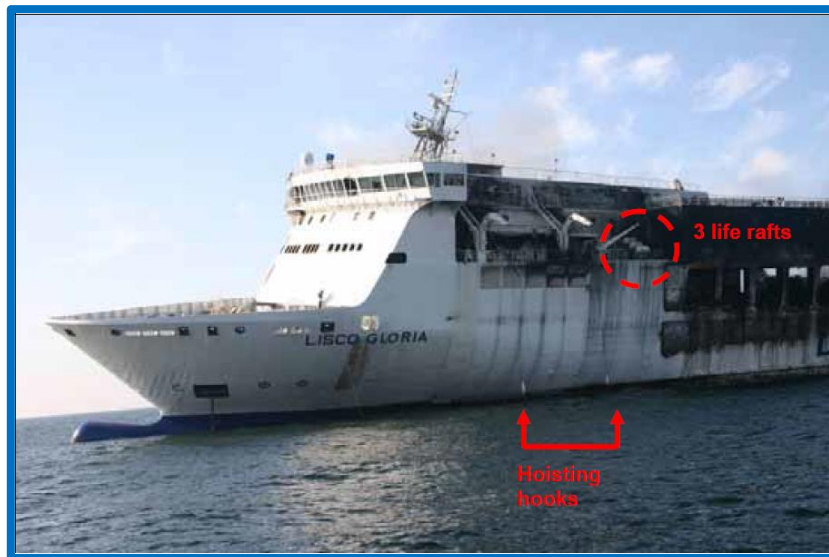
The organisation of lifeboat stations were smooth and when crew members faced difficulties loosening the lashing ropes they managed to quickly cut them off. All survival crafts were in good condition and were used in the evacuation.

Fig. (4): Due to successful evacuation by life boats, many life rafts were left unused, life boat lowering cables shown to be parallel lowered indicating smooth lifeboat lowering. Source: (Investigation Report 445/10, 2010)

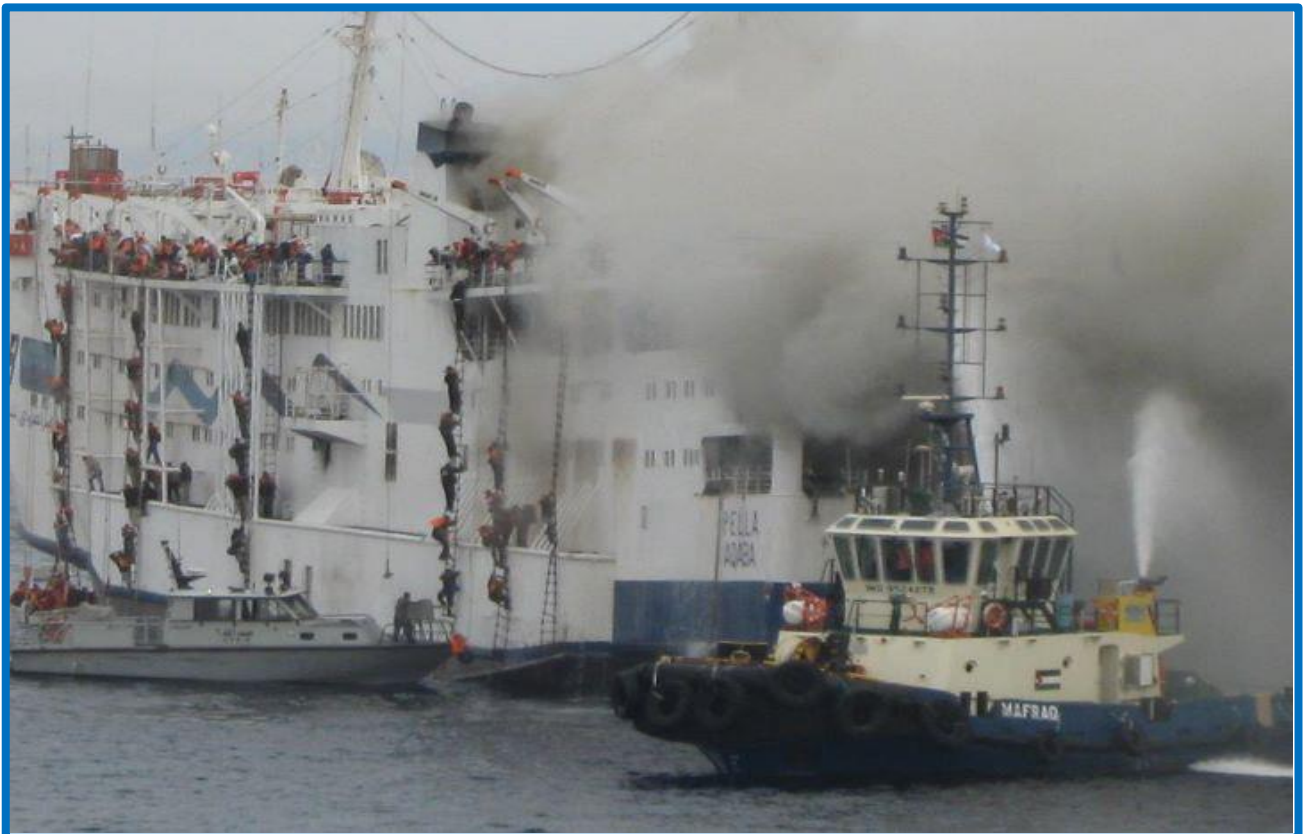
The evacuation procedures started at approximately 09:09 local time. Crewmembers started by evacuating women, children, elderly people and handicaps directly to the 4 lifeboats all wearing lifejackets. The lifeboats and life rafts were then launched. Rafts on the starboard side were then transferred to port side. Some small rescue vessels with length of 25 to 30 meters managed to rescue people directly from the ships' ladder without the need of the life rafts.

Fig. (5): Evacuation of the M/V Pella using embarkation ladders.

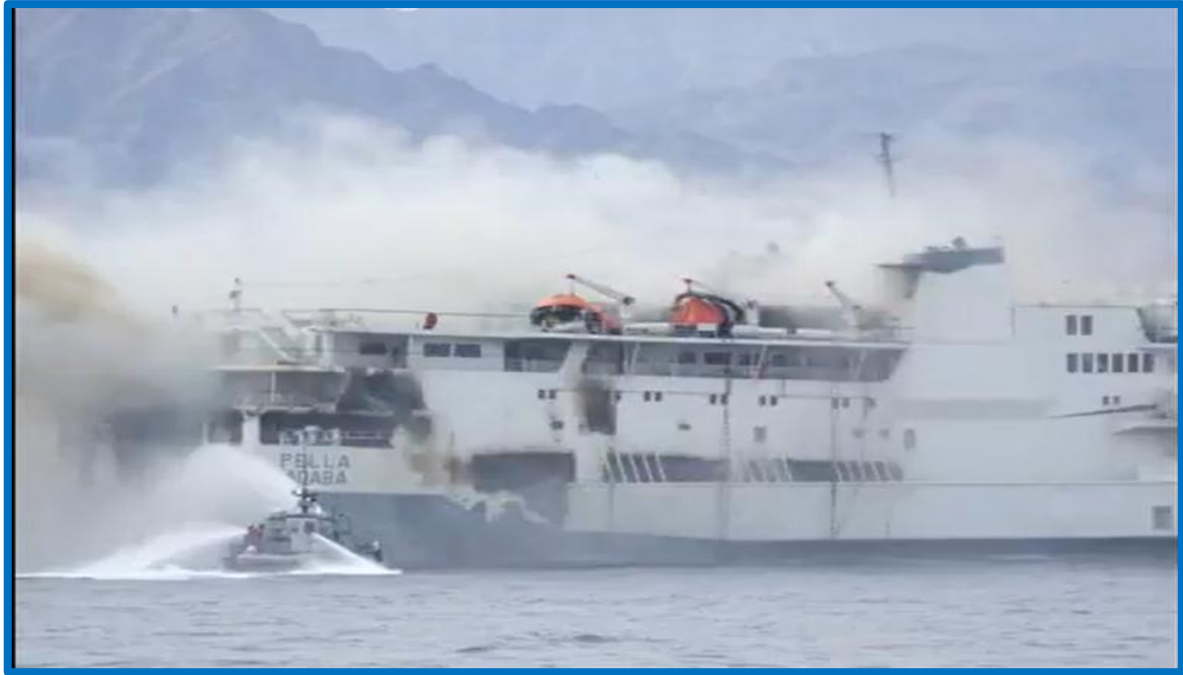
Fig. (6): Photo of unused life rafts due to the spread of the fire on starboard side. (Jordan maritime authority administration, 2008).

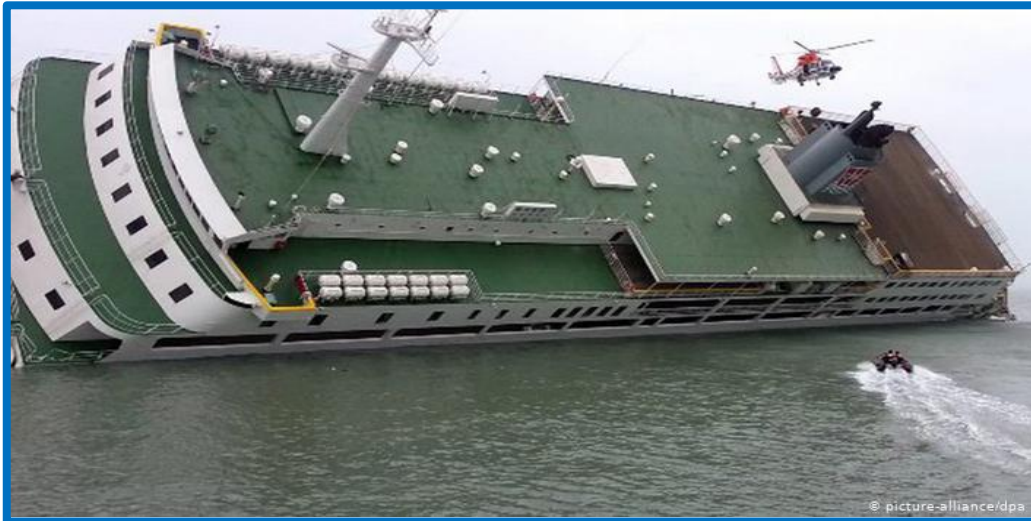
Orders to evacuate the vessel were never given or carried out. Lack of experience, and poor awareness of the vessel characteristics, loading conditions and environmental limitation that led to under estimate of the outcome of the sudden turn Inadequate training led to inadequate understanding or unaware of job duties in the event of emergency Thought there were enough time to wait for rescue craft to evacuate safely.

Fig. (7): A photo of M/V SEWOL before sinking, the photo shows that all life rafts were unused. Source: The New Yorker (2019)
