Potential Efforts for Conservation of Dayak Tomun Traditional House in Lamandau Regency, Indonesia

D. Condition of Components of the Dayak Tomun Traditional House

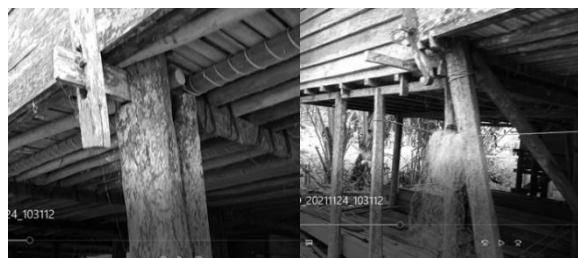
Fig 1. The pillars of the damaged traditional house building supported by wooden supports.

The pillars of the building are made of ironwood which are planted directly into the ground without using stones. The condition of the pillars of the building generally still looks good, although there are some pillars that are already visible starting to break and are supported by other support wood (Fig 1), there are also some that have started to have cracks at the ends of the pillars that are in contact with the ground. This happened because the condition of the supporting poles used had begun to shift (tilt and not perpendicular) from its initial position, so it needed to be supported by other wood. The cause could be the ground shifting or also the floor load at the point of the support pole. In addition, the wood of the support poles has begun to be attacked by fungus, which causes a change in color. Ironwood is classified as a very durable wood, so the fungus attack does not really affect the strength of the wooden pillars supporting this building.

Almost all of the pillars supporting the Dayak Tomun traditional house have been attacked by termites. The occurrence of land subsidence can also cause the pillars of traditional houses to tilt, where the supporting poles do not use pedestal foundations. In addition, by not using a pedestal foundation, if it is hit by a flood, it will accelerate the weathering of the material supporting the traditional house. Similar to the pillars of the building, the floor supporting beams also use ironwood

8. Building support poles: clean, repair by pasting on damaged wooden poles with wood that is the same or not stronger than the original, give anti-fungal and termite treatment, give foundation/base on each building support pole

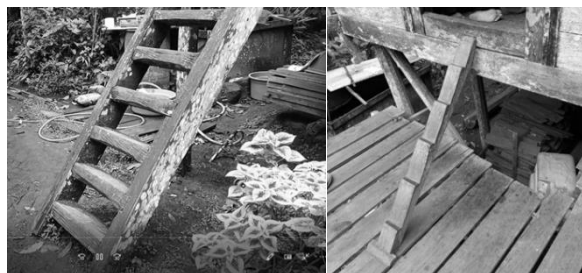
The condition of the outer stairs that stand from the ground to the terrace area of the traditional house is still quite good, although there has been a change in color with stains (white spots). These stains indicate that there is already mildew on the ironwood stairs. This can happen because the stairs are located in an open area. There is even moss growing on the left and right sides of the stairs of this building as shown in Fig 2. If you look closely, you can find some very fine hair cracks on some of the steps. The stairs of this traditional house are made of ironwood material. The wood is known as Class I wood, which is of very good quality. Even though it is quite old, it is still strong, but it is often exposed to rain, causing the stairs to become damp, and this condition is very favored by wood-destroying fungi. Of course, this needs to be addressed, so that the condition of the stairs can function properly.

Fig 2. The stairs to the terrace (left) and into (right) the traditional house of Dayak Tomun

Stairs from the terrace to the house using ironwood that is notched. The condition of this ladder is still very good and looks well cared for. Likewise, the stairs to the drying/laundry room, use ironwood that is notched. According to the owner of the household, it can be stored in the house at night. This habit is carried out because of their belief in protecting the occupants of the house from all possible dangers.

12. Outer wall and inner wall: clean and tidy up, repair by pasting on walls that are not suitable for use with the same quality wood material.
 13. Stairs: clean, give anti-mildew and anti-termite.

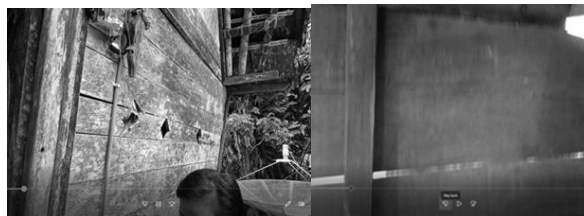
Fig 3. The outer (left) and inner (right) wooden walls of the Dayak Tomun Traditional House.

The walls of this traditional house of Dayak Tomun use boards made of ironwood. On the outside of the walls of wooden boards, it looks drier and lighter in color. Just like the other components, the exterior of this building is more often affected by natural/weather factors, so the color of the wood has also changed, unlike the original color (Fig 3). However, these natural/weather factors do not or very little affect the quality of this wooden plank wall. Meanwhile, the inner wall looks darker in color, and matches the color of ironwood (Fig 5). The wooden walls of this traditional house look still in very

good condition, although in some parts of the walls there are already visible gaps in the wooden plank walls. This can happen because the wood is hygroscopic (can experience shrinkage), and also the age of the wood is quite long (more than 50 years).

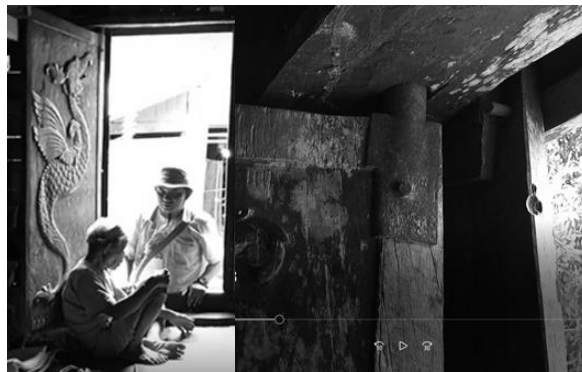
In traditional philosophy, the door is a barrier or meeting point (point of tangent) between the outer world which is not limited to the inner world which is ordered and limited. The door is a transition from unsafe or uncertain outside to a safe and certain area. The traditional house of Dayak Tomun has a very unique entrance. The door is made of very good quality ironwood material, and is engraved with the image of a dragon, as shown in Fig 4. Besides the entrance, there is also a door leading to the laundry and drying room, but the door is just plain, without any carvings. The condition of the doors is very good, and still functions well, although it looks like the wood has started to change color. Like most other building components in the house, there is this Dayak Tomun, the wood is left without being painted, the maintenance is very simple, just clean it from dust. The doors in this building use iron hinges on the top and bottom of the door leaf.

Fig 4. The door engraved with a dragon image.

9. Roof: adjust to the quality of the previous material, texture, arrangement and pattern as before.
 10. Doors: clean, give anti-mildew and termite-proof treatment, the color quality or paint of the wood should be the same as before.

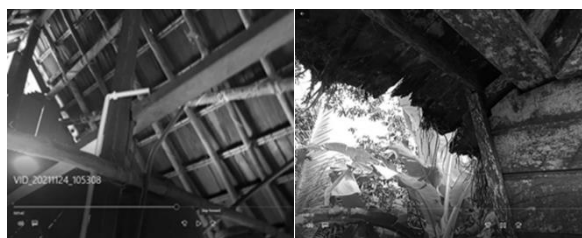
The roof frame of this building uses a ring beam of ironwood material at the bottom. The condition of the ring beams from the roof truss of this building is still quite good (Fig 5). The ironwood which is used as the ring beam becomes the support for the horses and the battens on the roof truss. The condition of the ironwood block ring is still quite good. Meanwhile, the horses and battens for the roof cover use bamboo material. The rafters of bamboo material are arranged tightly about 60 cm, as well as the battens that cover the roof with a distance of + 50 cm. The diameter of the bamboo for the roof truss is about 8-10 cm. The width of the bamboo battens is about 2 cm which is composed of 2 - 3 small bamboo sticks of small diameter (Fig 5).

The bamboo rods for the battens are tied with bamboo ropes. The condition of the horses and battens looks still quite good. Tree bark made of ironwood material is used to cover the roof of the Dayak Tomun traditional house. The bark of the ironwood tree is indeed a common material used in Dayak Tomun stilt houses. As a roof covering, of course, it is often exposed to rain. In some parts of the roof covering has been damaged, and must be replaced immediately, so that water does not enter the building or damage other components of this building.

Fig 5. The roof frame and roof covering of the Dayak Tomun Traditional House
